XVIII. TÜRK TARİH KONGRESİ

Fatih Mosque in Prishtina

Orges Drançolli*

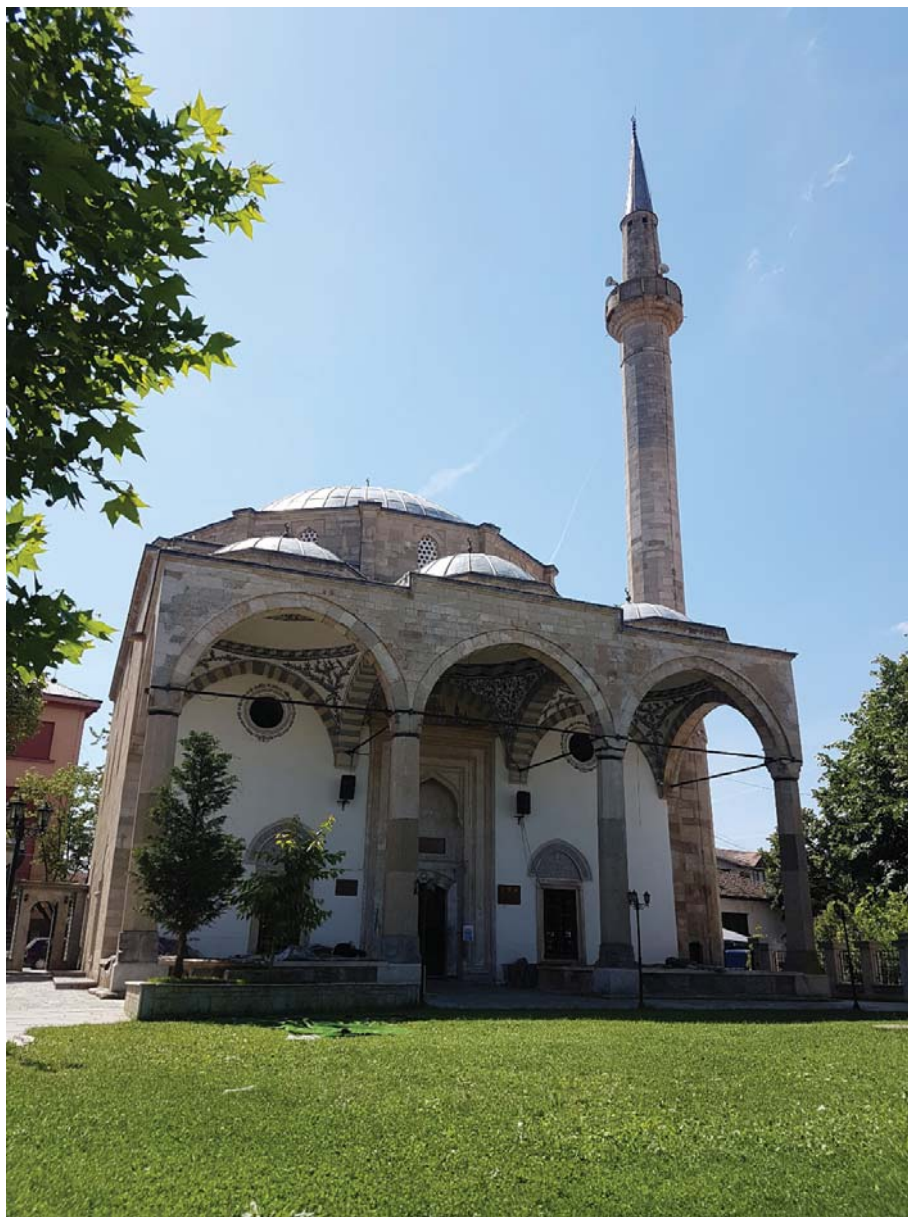
Fig. 3: Frontal view of the Fatih Mosque in Prishtina

The mosque has an open portico, which is covered with three smaller domes that stand on colonnade of four pillars. The smaller domes, serve as contrast to the bigger central dome affecting the esthetical aspects of the mosque. The portal represents the most monumental part of the building. It is covered with architrave. Above that is the inscription with the date and the name of the donor²⁰.

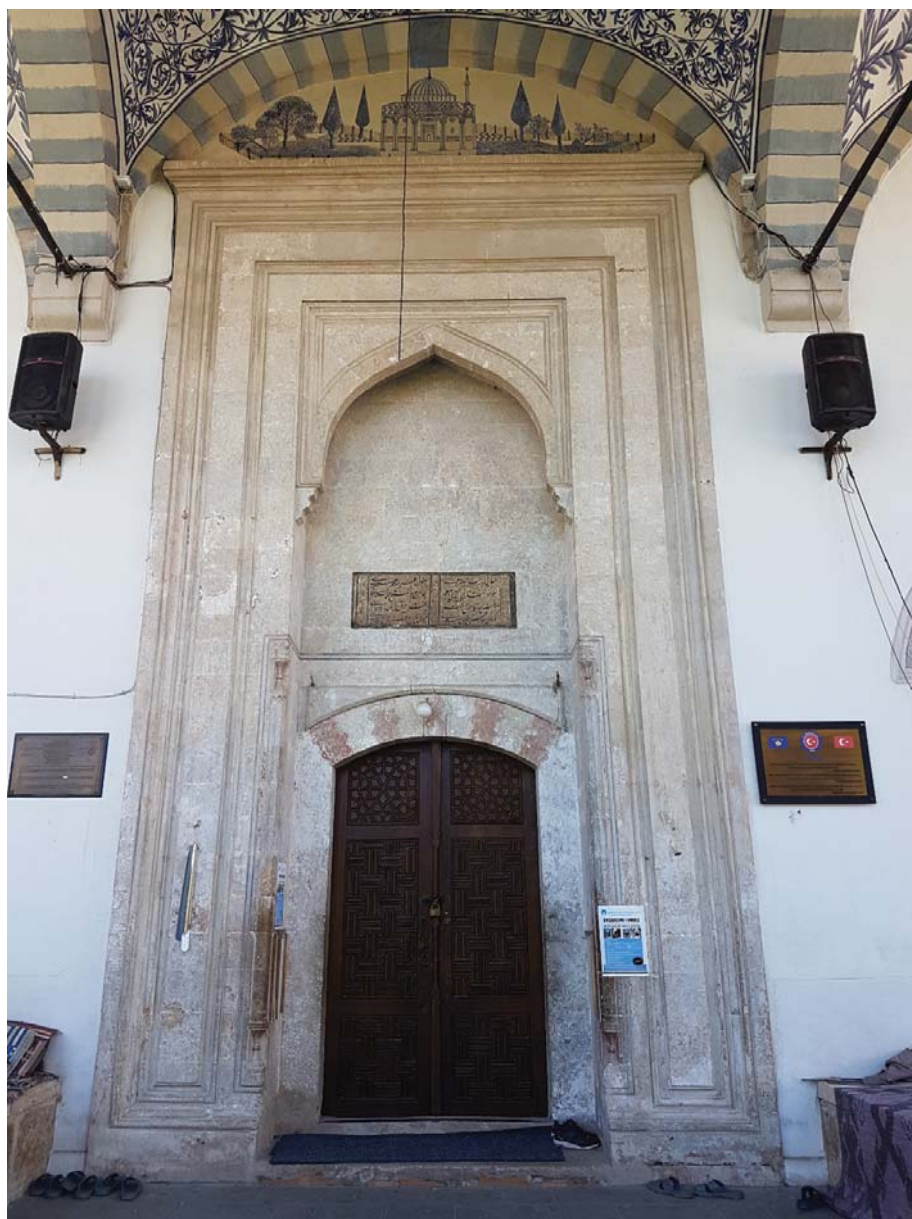
Fig. 5: Portal of the Fatih Mosque in Prishtina

In comparison with other mosques in territory of Kosovo, the portal of Imperial Mosques stands out for its rich constructive, architectonic and decorative elements.

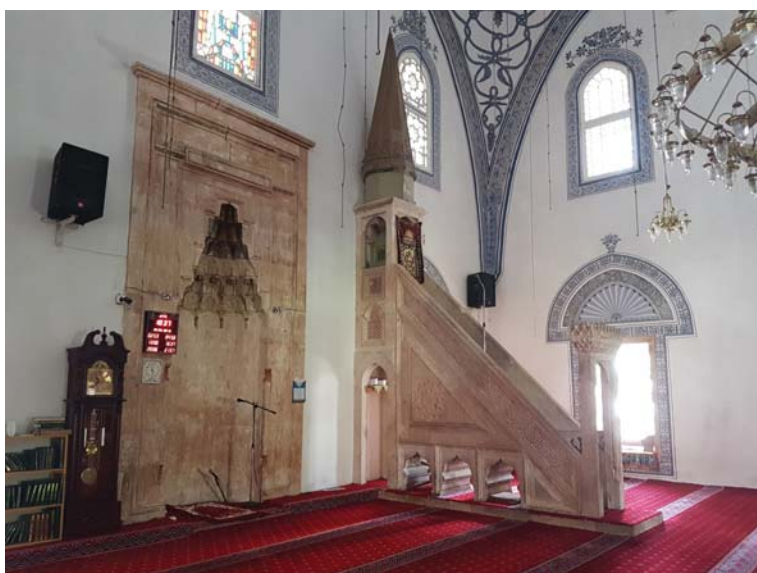
Fig. 7: Mihrab and Minber of the Fatih Mosque in Prishtina

The interior of the Imperial Mosque is filled with decorations. Paintings realized in secco technique mainly dominate, but there are parts decorated in low relief sculpture as well. Obviously, as in every other mosque, mihrab stands out as the most decorated part of the interior. It is a form of niche and stands on the slightly raised platform. On the niche part is decorated with ottoman style muqarnas realized in stucco. Low relief sculpture is applied in the outer part of the niche, mainly in the frame of the mihrab but on top of niche as well.

On the right side of the mihrab, a minbar is constructed. A minbar is fully constructed from stone and, same as the mihrab and muezzin mahfil, it stands on a slightly raised platform. It has eleven steps and is covered with polygonal spire. It represents one of the elements that preserves the originality from the time of its realization. It is rich with decorations on low relief sculpture like rosette, muqarnas, and geometrical shapes. On the left corner of the mihrab wall rostrum (*kürsü*) is located. It has the shape of a flipped cone. In its lower and upper part of the cone is painted with stylized flowers and profiled with low relief sculpture, whereas, the upper part is decorated with wooden decorative grill.
